Cheetah II (SCZII) Steering Control Lever Interference

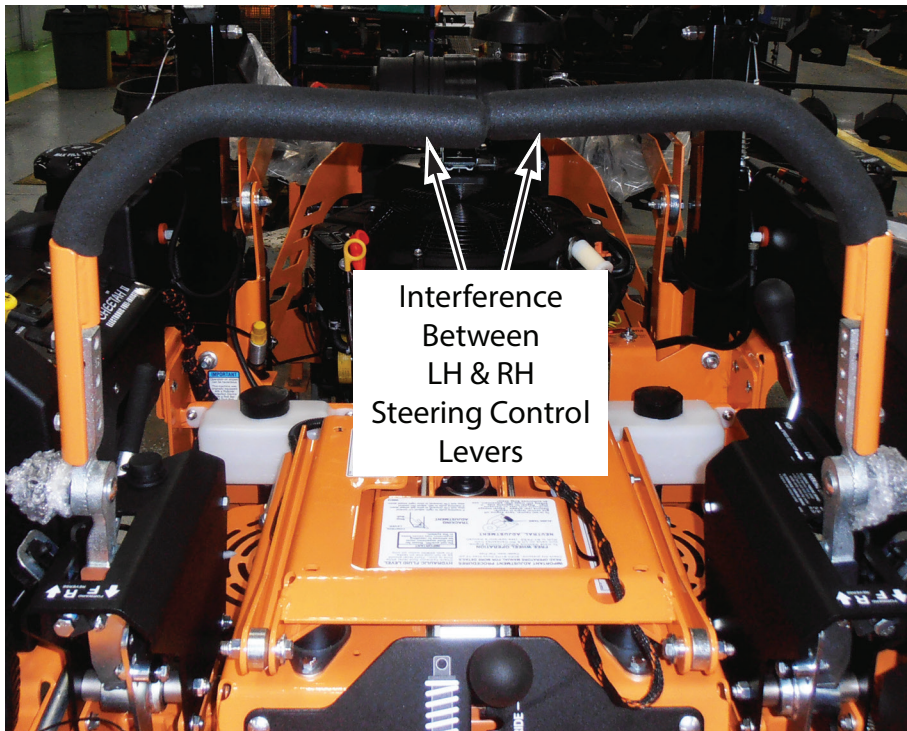
We have received reports from the field involving a limited number of Cheetah II (SCZII) machines experiencing interference between the LH & RH Steering control levers. See Figure 1 below.

Figure 1. Control Lever Interference

This condition can be resolved by installation of spacer part number 431179 in the LH & RH pivot control weldments as described on Page 2.

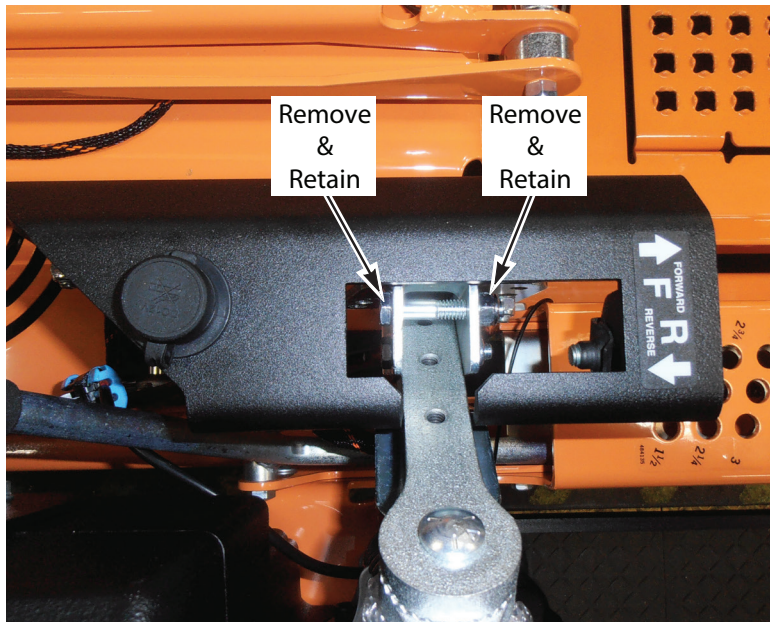
Figure 2. Remove & Retain Hardware - RH Shown

- 1.) Remove and retain the 5/16-18 x 1-3/4" hex head bolt and 5/16-18 elastic stop nut identified in Figure 2 below.

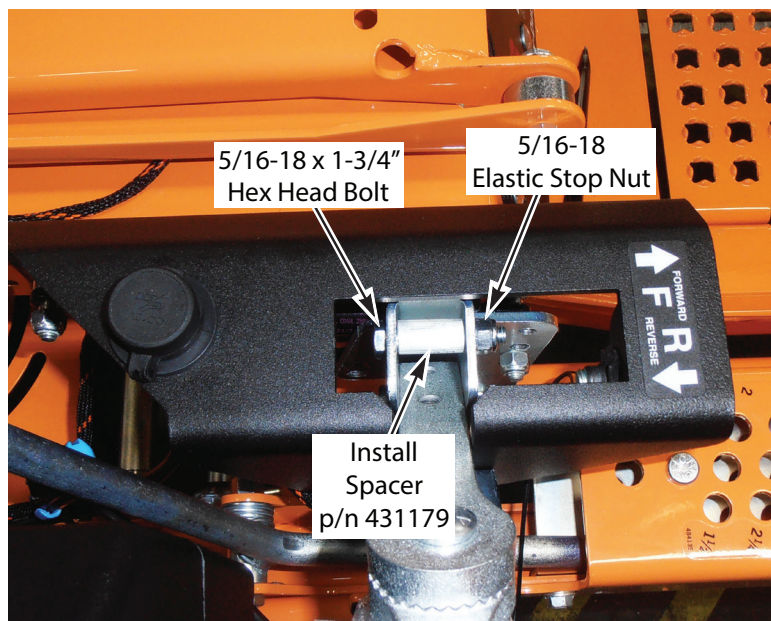
Figure 3. Install Spacer p/n 431179 - RH Shown

- 2.) Install spacer p/n 431179 and secure using 5/16-18 x 1-3/4" hex head bolt and 5/16-18 elastic stop nut removed in previous step. See Figure 3 below.

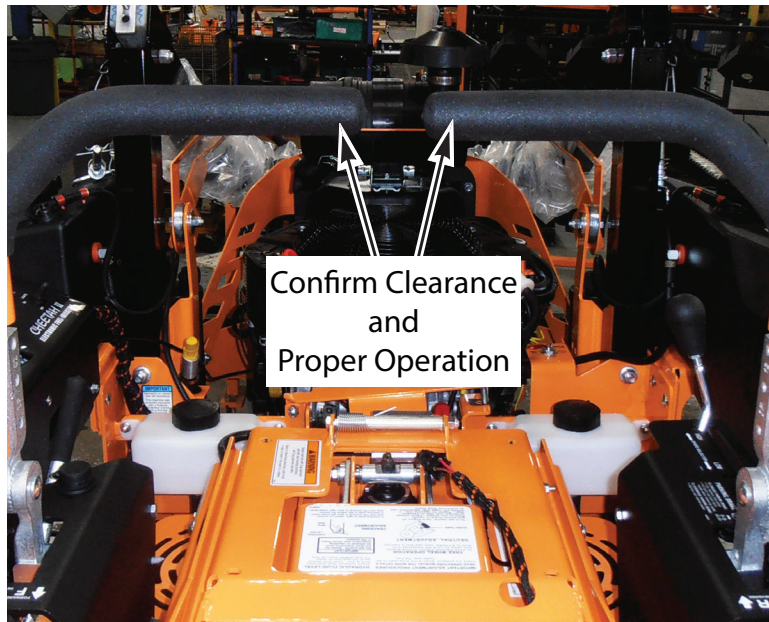
Figure 4. Check Clearance & Proper Operation

- 3.) Install spacer p/n 431179 on the LH pivot control weldment following the procedure described in steps 1 & 2.
- 4.) Inspect the LH & RH steering control levers for clearance and proper operation. See Figure 4 below.
